## SECTION 501-27: Front End Sheet Metal Repairs

**VEHICLE APPLICATION :** 2003.0 BA Falcon

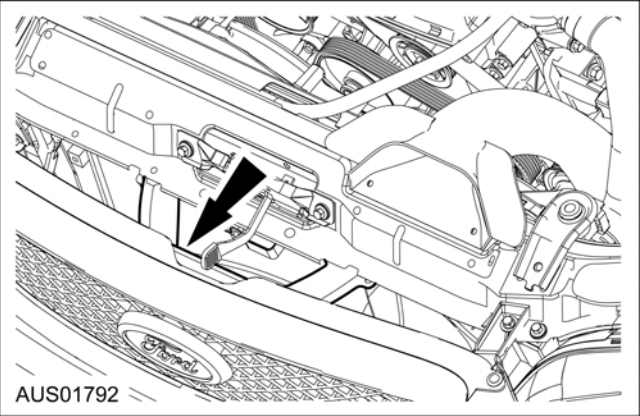
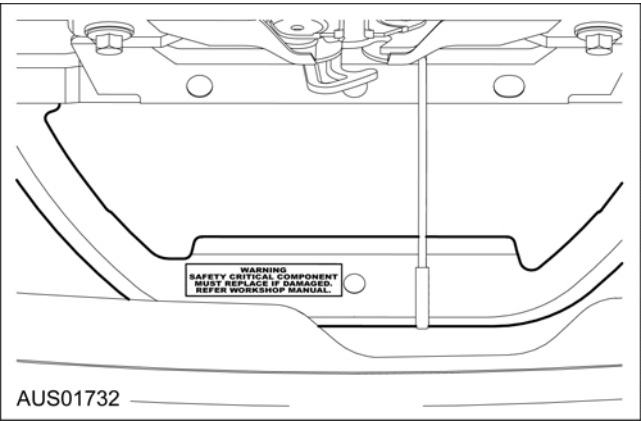
Towel Rail Replacement

The Towel Rail on the front upper X member must be replaced if damaged. It MUST NOT be straightened or panel beaten. This is critical for correct function of the crash severity sensor which plays a major part in activating the front airbags in a crash.

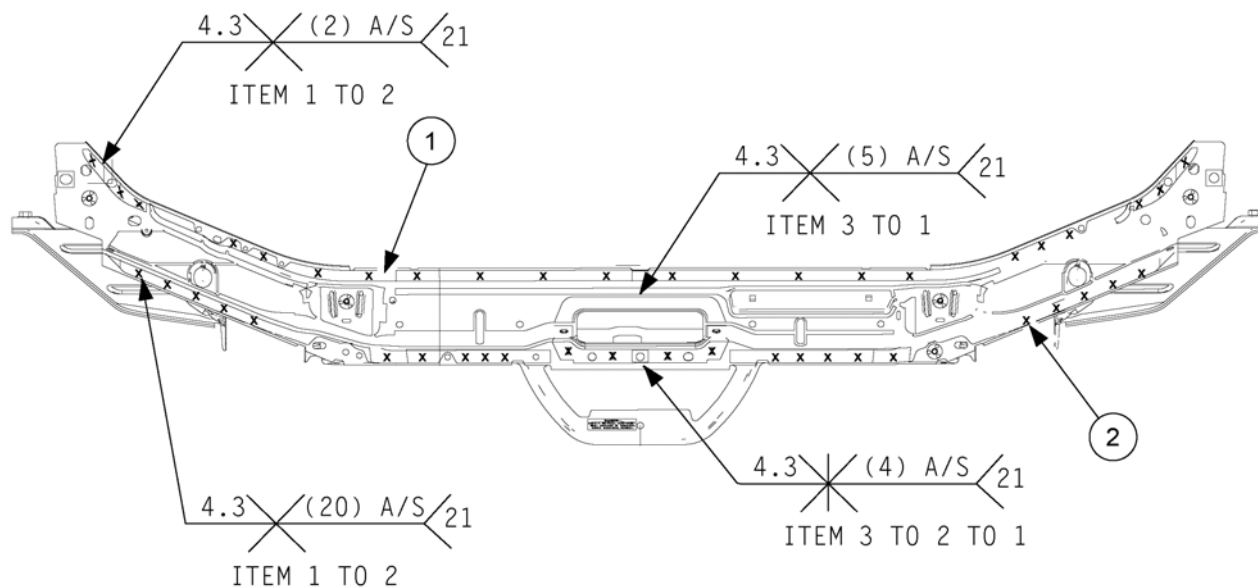
**WELD INFORMATION (Continued)****Radiator Cross Member 2**

1	Upper Front Cross Member
2	Reinforcement - Upper Front Cross Member
3	Support Hood Latch

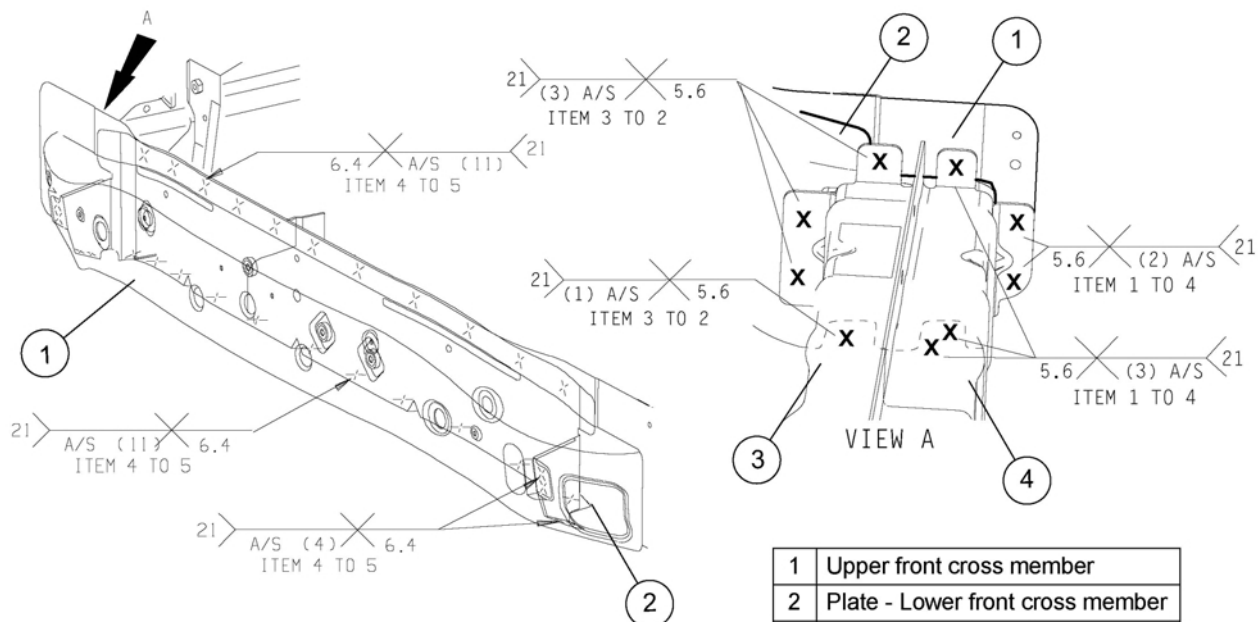
**Radiator Cross Member 3**

1	Upper front cross member
2	Plate - Lower front cross member
3	Inner front side member
4	Outer front side member
